## **DEPARTMENT OF TRANSPORTATION**

**[Docket No. FAA-2021-0872; Project Identifier MCAI-2021-00312-R]**

#### **Airworthiness Directives; Airbus Helicopters**

**ACTION:** Notice of proposed rulemaking (NPRM).

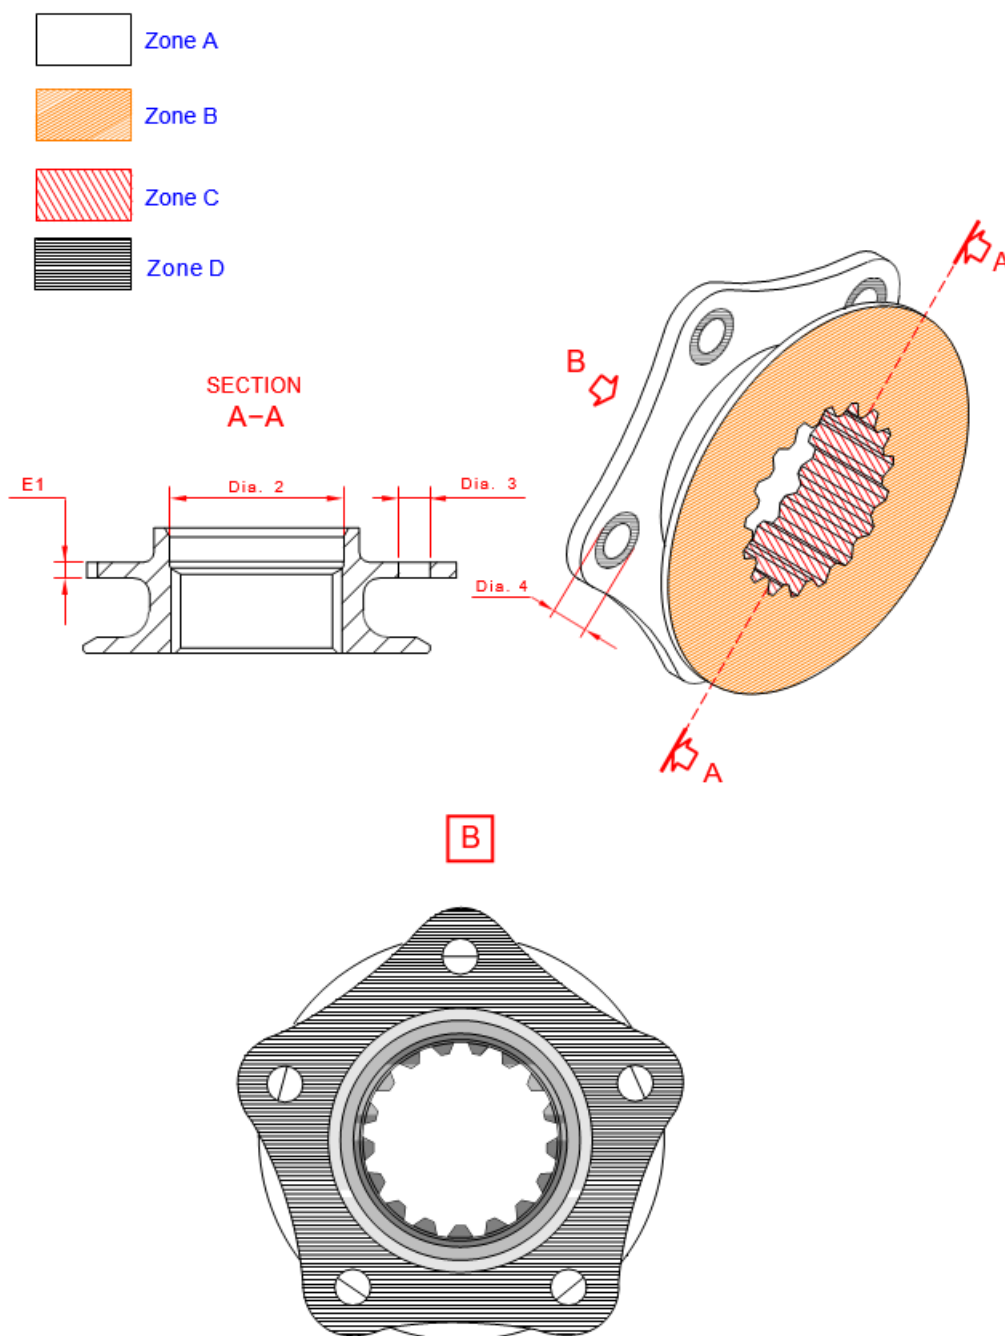
**Figure 2 to paragraph (g)(1)(ii) – Inspection Areas of Tail Rotor Splined Flange**

(ii) Inspect the TR splined flange for corrosion, impacts, fretting, wear, and a crack in the areas identified in Figure 2 of this AD. If the condition of the part (including corrosion, impacts, fretting, wear, or cracks) exceeds the criteria as specified in Figure 1 of this AD, before further flight, remove the splined flange from service and replace with an airworthy part.

<i>Flange</i>	
<b>Location as specified in figure 2 to paragraph (g)(1)(ii) of this AD</b>	<b>Maximum damage, which causes replacement (E1, Dia. 2, Dia. 3, and Dia. 4 are shown in figure 2 to paragraph (g)(1)(ii) of this AD)</b>
Zone A	Scratch depth > 0.2 mm (0.008 in.). Crack. E1 < 2.75 mm (0.108 in.). Dia. 3 > 6.02 mm (0.2371 in.). Dia. 2 > 33.03 mm (1.3004 in.).
Zone B	Touch-up depth > 0.1 mm (0.004 in.). Crack.
Zone C	Crack. Scratch depth > 0.2 mm (0.008 in.).

Location as specified in figure 2 to paragraph (g)(1)(ii) of this AD	Maximum damage, which causes replacement (E1, Dia. 2, Dia. 3, and Dia. 4 are shown in figure 2 to paragraph (g)(1)(ii) of this AD)
Zone D [Dia. 4 = 14 mm +/- 0.1 mm (0.548; 0.555in.)]	Touch-up depth > 0.1 mm (0.004 in.). Crack. E1 < 2.75 mm (0.108 in.).
